Detecting Hidden Risks: Advanced Endwinding Vibration Monitoring on a 110 MW Hydrogenerator

Veski Ltd
Croacia

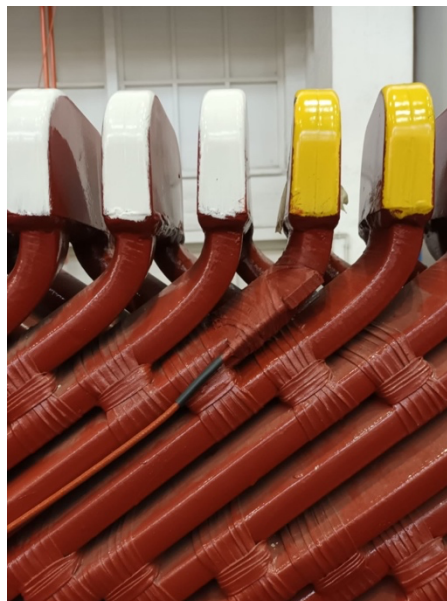
Endwinding vibration sensor on a hydro generator endwinding (IRIS EVAIL)

Monitoring endwinding vibrations requires [Fiber optic accelerometer](#) technology due to its ability to operate in high-voltage environments without being affected by electromagnetic interference. The monitoring system also includes software for data interpretation, tracking vibration progress, and preventing possible failures.
