# Machine condition assessment of a 415 MW unit based on off-line and on-line measurements

The paper describes different diagnostics methods, both off- and on-line, that were applied during and after the overhaul on 415 MW vertical Francis hydro-unit, in order to obtain insight into its mechanical state condition for safe operation and future refurbishment.

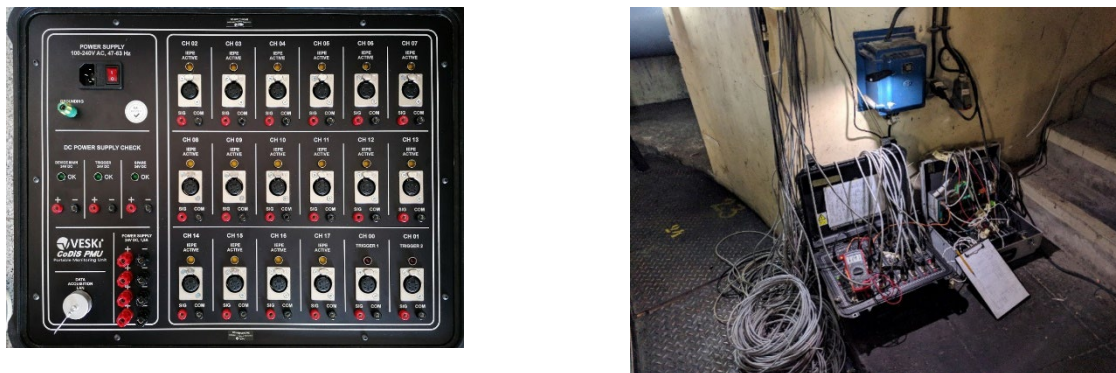
Fig 2. LEFT: Portable Measurement Unit (PMU) – an 18 channel signal conditioning and acquisition device. RIGHT: Two PMU’s running synchronously with all signals connected. Photo from the power plant.

These analog inputs were connected to appropriate monitoring hardware and software used for data collection and interpretation. Portable instrument with connected signals and some probe photos are given in Fig. 2. and Fig. 3.

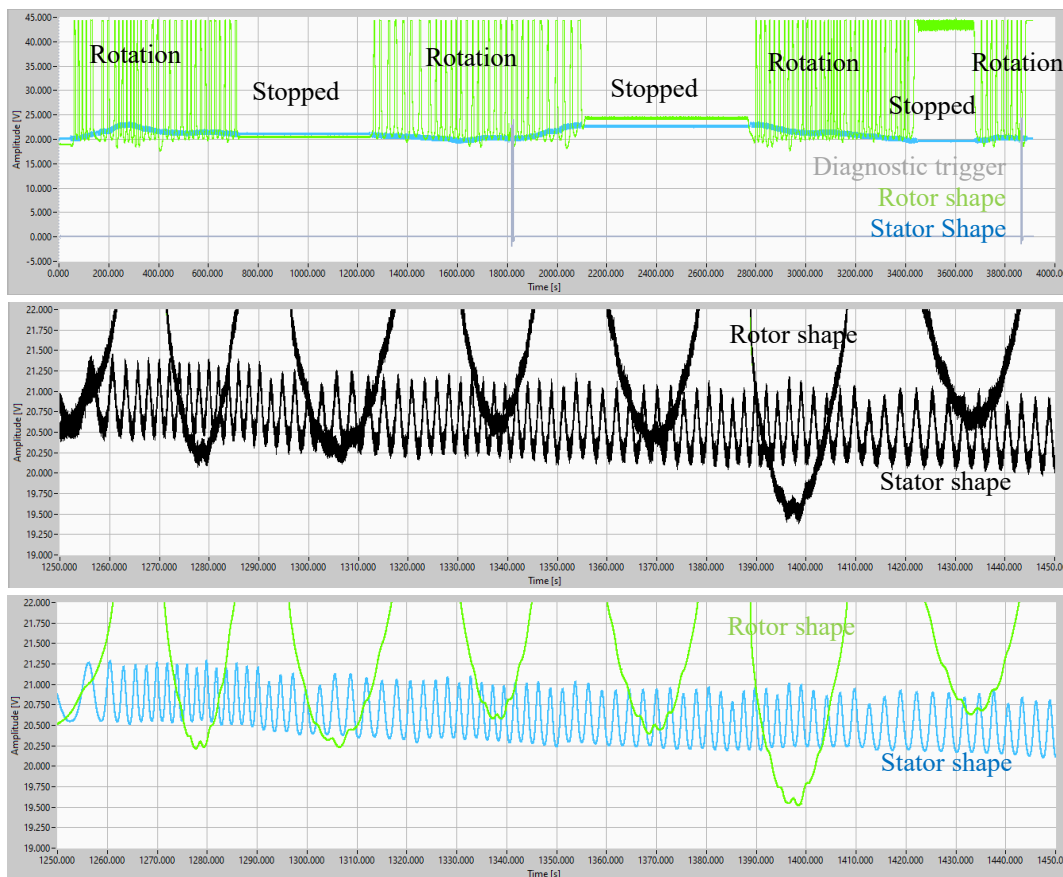
An example of the waveforms recorded for the measurements in bottom plane are shown in Fig. 4. Additional signal filtering was performed to reduce white noise as indicated in the figure.

Fig. 4 TOP: Waveforms in duration  $\sim 3$  h and 5 minutes (two revolutions). MIDDLE: Original waveforms (white noise present). BOTTOM: Waveforms with white noise reduced. Y scale in [mm].

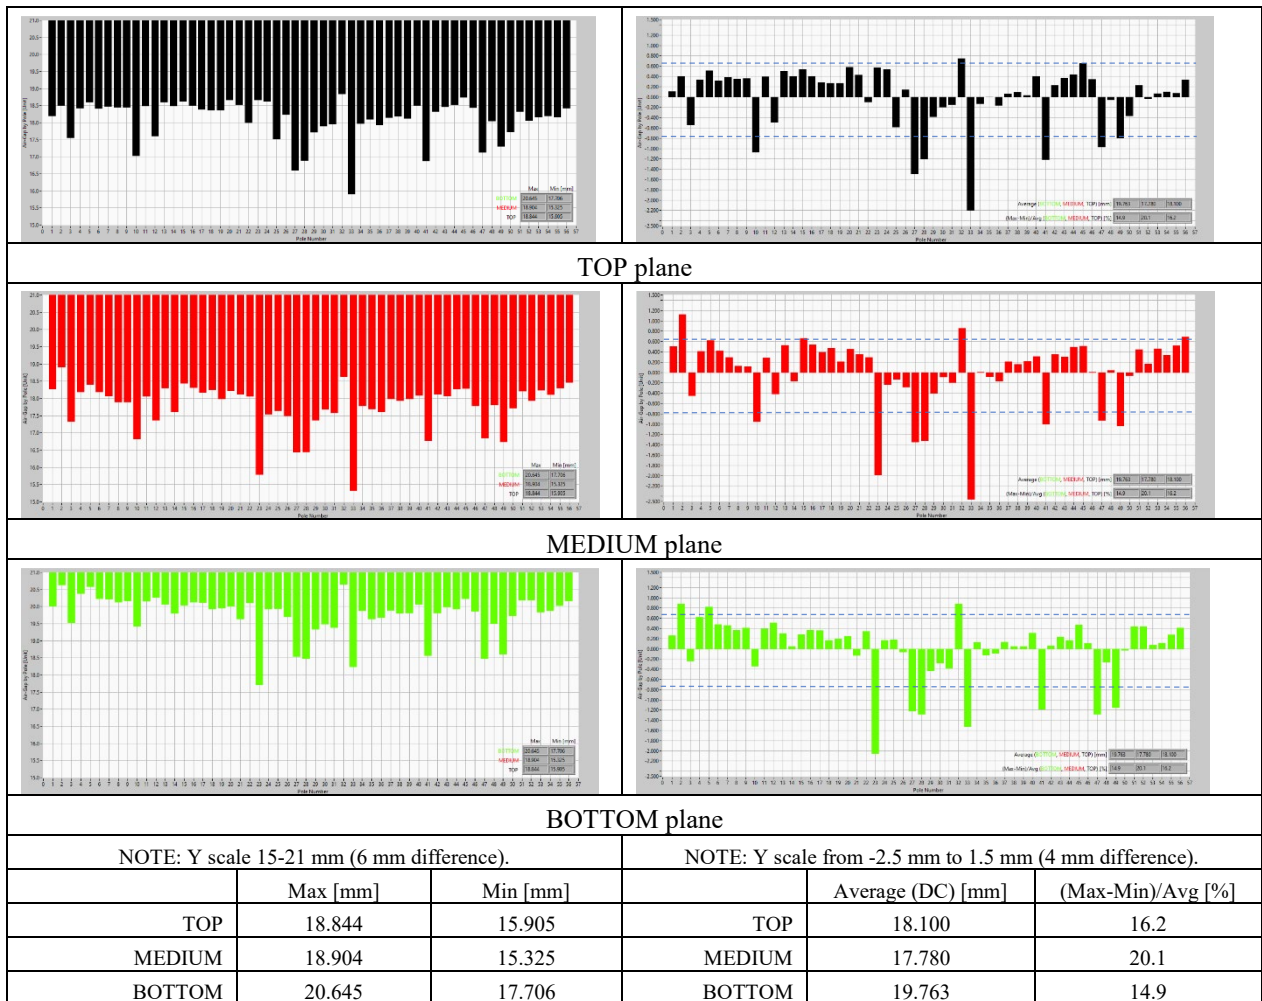
Fig. 5 LEFT side: Bar-graph view of the rotor shape by pole number in all three (3) measurement planes (top, medium, bottom). Numbers at the bottom indicate maximum and minimum air-gaps found. RIGHT side: Bar-graph view of the deviation of the air-gap from average (DC) value by pole number in all three (3) measurement planes (top, medium, bottom). Numbers at the bottom indicate average (DC) and percentage of deviation of the air-gap by measurement planes (top, medium, bottom).  $\pm 3\%$  ( $\sim \pm 0.7$  mm) lines drawn on the graph.

This figure shows that the average air gap is largest at the bottom plane and decreases when reaching top plane (where it's at 18.1 mm). All measured air-gaps are smaller than the design value of 22.6 mm. Additionally, it can be seen from figure that the poles 23 and 33 deviate from average value the most, though there are other poles which deviate as well (poles 2, 10, 27, 28, 32, 41, 47 and 49). The circularity is above recommendations (CEATI).

Visual inspection complemented by NDT helps plan monitoring activities and increases unit operation reliability. In this case, recommendation was given to rewedged some poles which would reduce magnetic unbalance and the related stator frame vibrations. Also, recommendation was given to grease certain areas of the soleplates to allow for a more uniform stator frame expansion. After this is done stator to rotor eccentricity could be checked and stator moved, if necessary, to reduce any remaining stator to rotor eccentricity on unbalanced magnetic pull.

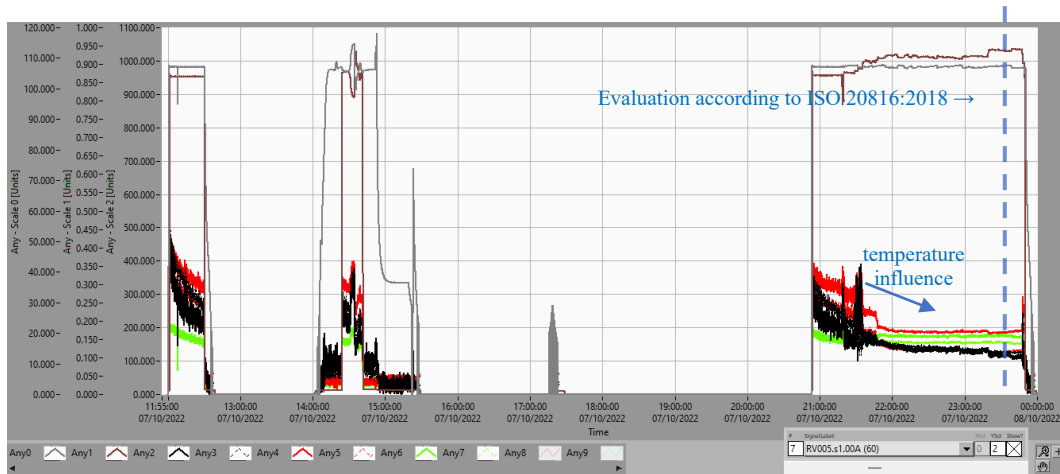
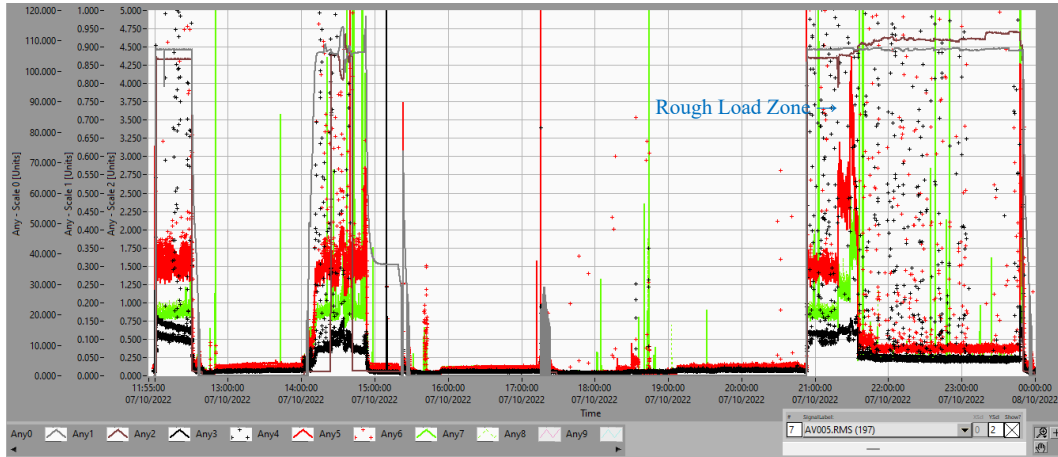
Fig. 9 TOP: Rotational speed [rpm] – Y scale 0, magnetic field RMS value [T] – Y scale 1, relative vibrations 1x peak-to-peak values [µm]. UGB – black, THRB – red, TGB – green. Direction X – thick line, direction Y – dashed line. BOTTOM: Rotational speed [rpm] – Y scale 0, magnetic field RMS value [T] – Y scale 1, absolute vibrations RMS values [mm/s]. UGB – black, THRB – red, TGB – green. Direction X – thick line, direction Y – dashed line. Rotational speed – gray, Magnetic field – brown.

Fig. 9 shows that the vibrations have stabilized at the top of the zone A-B after the unit reached steady state temperatures. Also, from the bottom diagram on Fig. 9 it can be seen that some points 'jump' to high values and returns to previous values. The trend is clearly visible, though, and the reason for this sensor behavior is related to the saturation of the piezo-electric crystal with high frequency acceleration and not the machine vibrations. Mechanical filters can be used to attenuate this but were not available in the power plant during the measurements.

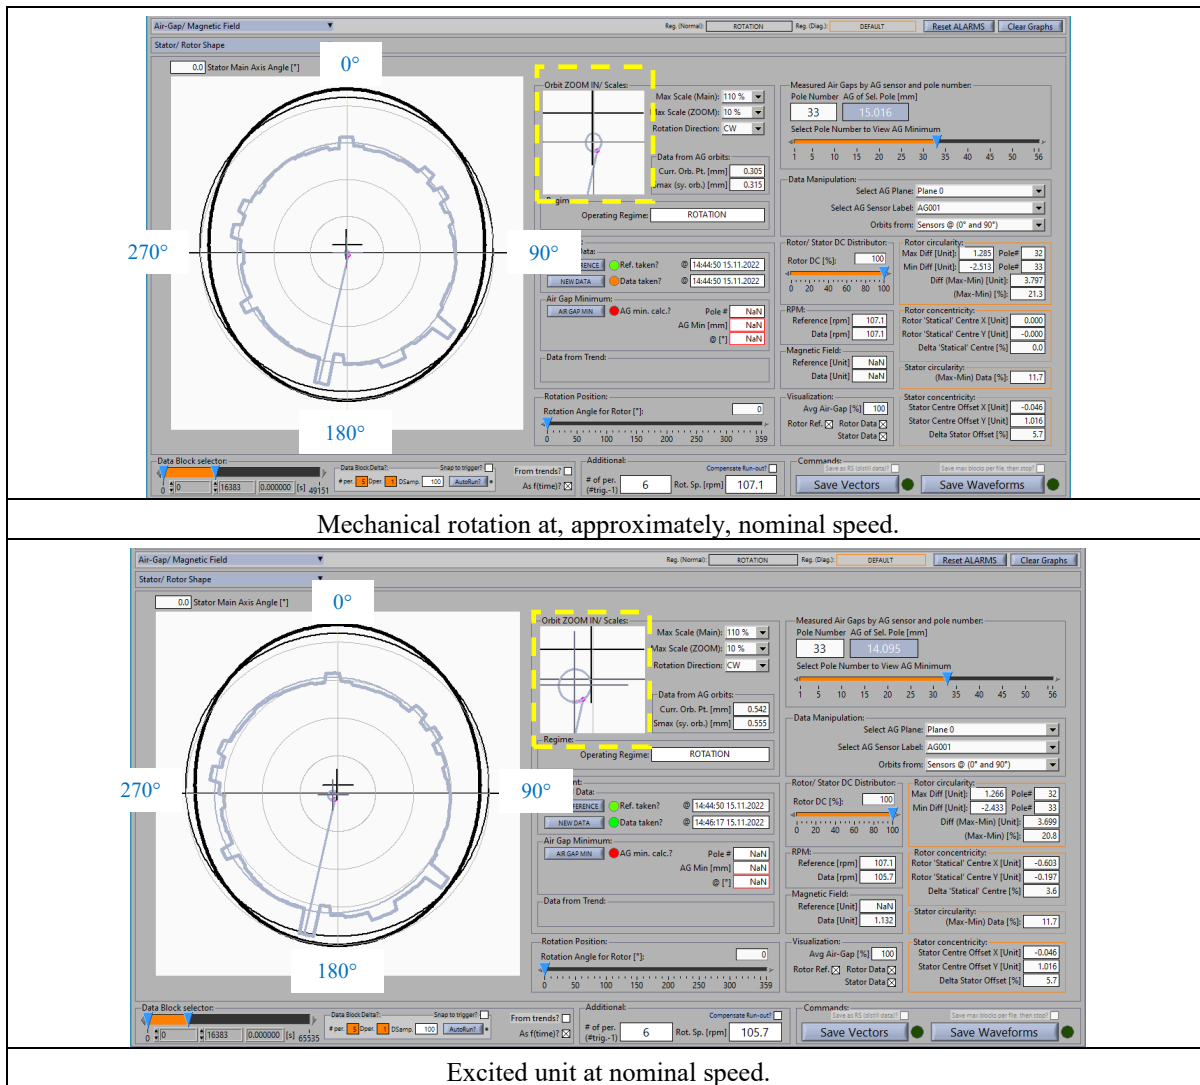
Fig. 11 Rotor and stator polar plots in mechanical rotation at nominal speed (TOP) and excited unit at nominal speed (BOTTOM). Orbit ZOOM IN shows the direction of the statical (DC) displacement, which correlates well to Fig. 6 and Fig. 10. The same Orbit ZOOM IN shows increase in orbit size due to vibrations within the air-gap (AC).

Fig. 10 and Fig. 11 shows displacement as a consequence of the unbalanced magnetic pull due to the asymmetry within the air gap. Detailed analysis of the influence of magnetic asymmetry around stator and rotor clearly showed that there is a correlation between 1x vibrational vectors within the bearings and the air-gap which, practically, proved that the rotor non-circularity is the main reason for the magnetic unbalance. As such, recommendation was given to the plant to rewedge some poles (related to the offline measurement results) which would improve magnetic unbalance influence and also reduce 2x stator frame vibrations originating from the rotor shape. After that, most likely, balancing would be required.

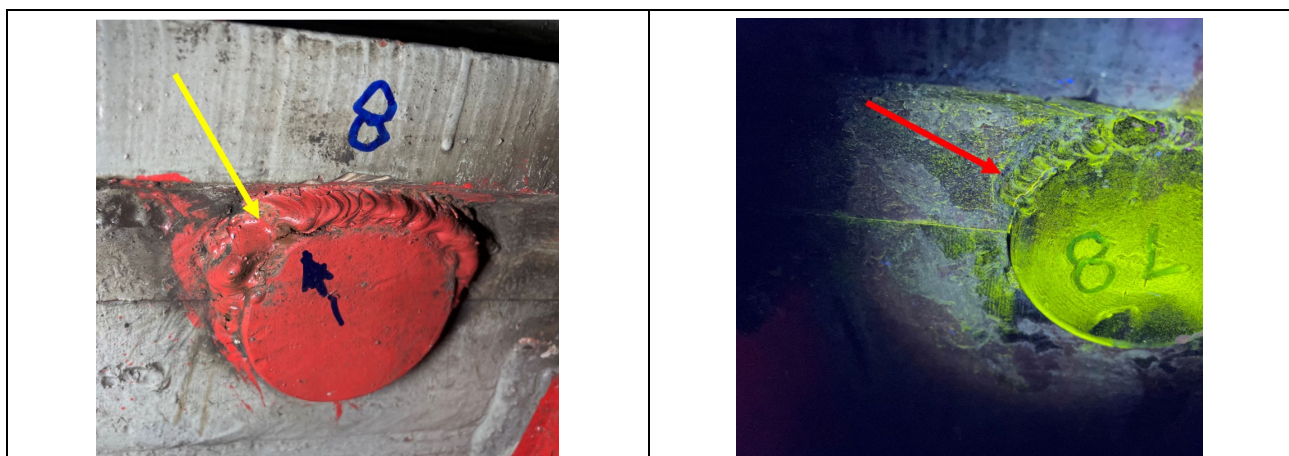
The NDT and visual inspection of the unit revealed the cracks in the part of the radial pin which was welded to the frame (top part) in order to prevent it's migration during stator expansion. This is shown in Fig. 13.

Fig. 13 Linear indication (crack) on securing weld on stator soleplate radial pins.
