# Root cause analysis on a 110 MW hydro unit based on vibration and air gap monitoring data

The paper describes the root cause analysis of increased turbine shaft displacements on a 110 MW hydro-unit. A monitoring system, which collects vibration, flux and air gap data continuously, detected an unstable machine vibro-dynamic behaviour, manifested through the abrupt (and excessive) shaft displacement and vibration increase on turbine guide bearing (TGB) as well as on generator guide bearings. TGB displacements reached 500-900  $\mu\text{m}$  peak-to-peak and machine was put out of operation. Even though everything pointed to turbine related problem the analysis showed that, alongside vibration increase, the unusual continuous increase in air gap values was present as well, followed by rotor concentricity offset. All resulted in disrupted unit shaft line and consequently with increased shaft displacement on TGB. The paper clearly shows how analysis and cross-correlation of vibration and air-gap signals is crucial in successful diagnostics and localization of the root cause on hydro generators.

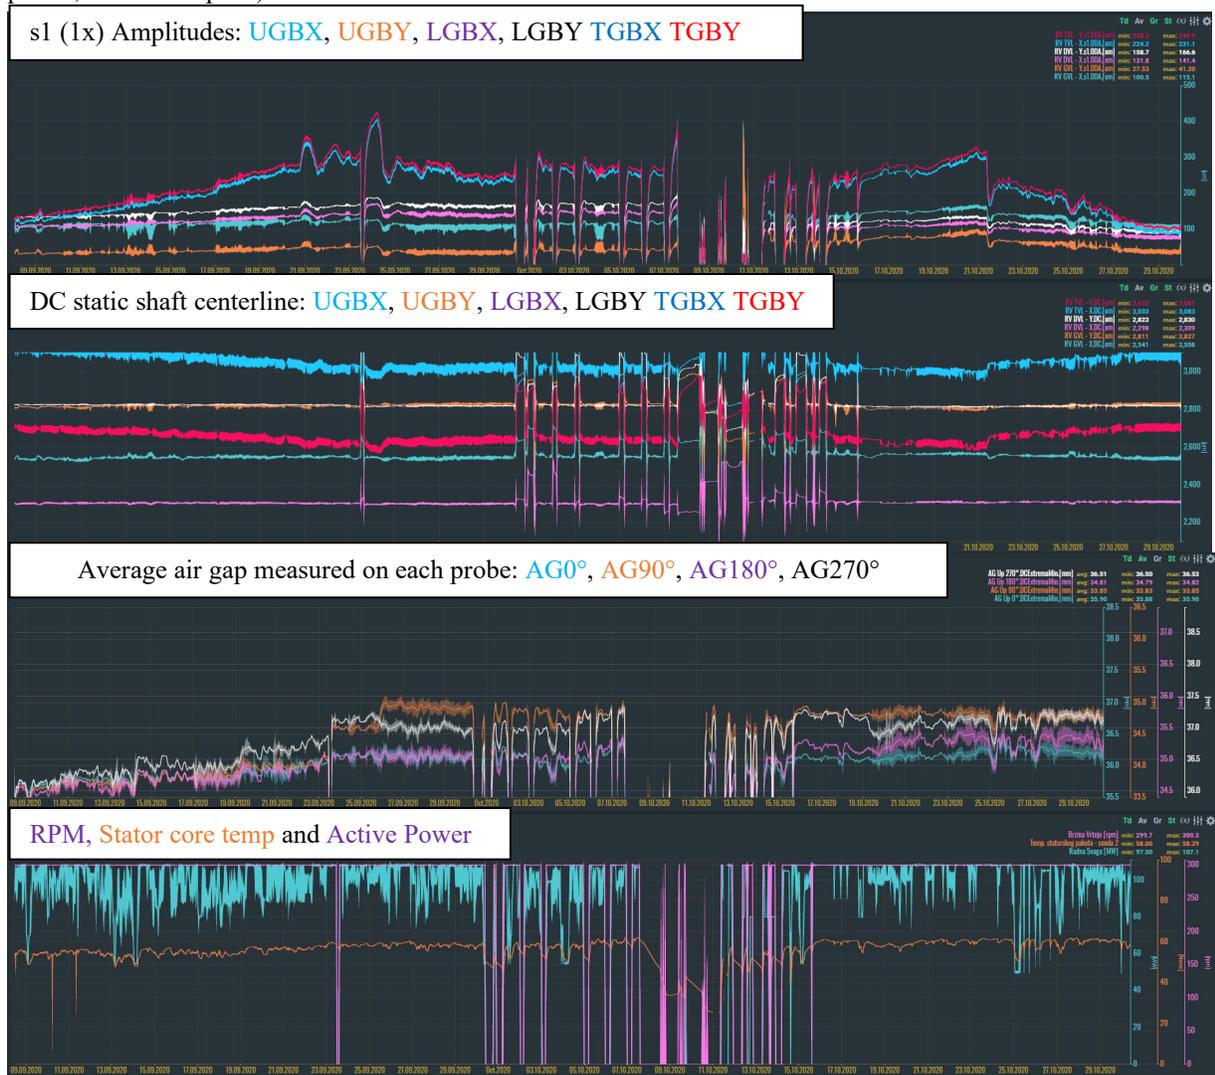
Fig. 3 shows trends of 1x harmonic of relative shaft vibration for each bearing plane (X and Y directions, mutually perpendicular), DC value at each proximity probe for each bearing plane (X and Y directions, mutually

perpendicular), DC values of the air gap (average of all poles), process parameters (stator core temperature, active power, rotational speed).

Fig. 3 DIAGRAM 1 (TOP): 1x harmonic (relative vibrations peak); DIAGRAM 2: Static shaft position on UGB, LGB and TGB; DIAGRAM 3: Average (DC) value of all air gap values by pole; DIAGRAM 4 (BOTTOM): Stator core temperature, active power, rotational speed.

From the beginning of trends on Fig. 3, till September 21<sup>st</sup> the vibration amplitudes on turbine bearing (TGB) increase, practically, linear to values of ~250-300  $\mu\text{m}$ . On UGB and LGB this increase exists too, but is much slower. On LGB the values reached are ~140-180  $\mu\text{m}$  and on UGB in direction X up to ~120  $\mu\text{m}$  and in direction Y ~50  $\mu\text{m}$ .

From September 21<sup>st</sup> begins the uncontrolled vibration increase in which the vibration amplitudes on TGB exceed 400  $\mu\text{m}$  peak values.

The statical (DC) shaft positions on UGB and LGB are, practically, unchanged during the entire analysis period, and the same statical shaft positions on TGB are continuously changing up to the moment the vibrations increased abruptly and excessively. After the vibration have stabilized at very large values (250-300  $\mu\text{m}$  on TGB, 160  $\mu\text{m}$  on

LGB and 100  $\mu\text{m}$  on UGB) the statical shaft position stops changing on TGB (red and blue lines on diagram 2, Fig 3.).

The bottom two diagrams (diagrams 3 and 4) on Fig. 3 show process quantities (stator core temperature, active power, rotational speed) and average (DC) value of all air gap values by pole for all four (4) air gap sensors. The vertical scale range for air gap is 3 mm and the way the starting point is selected is that at the diagram beginning all of the air gaps start from the same point. In this way, changes in air gap on all measurement positions can be tracked visually. For example, the scale of sensor at 0° is from 35.5 mm to 38.5 mm and the sensor at 270° from 36.0 mm to 39.0 mm.

It is noticeable from Fig. 3 that the air gap continuously increases even though machine operates at the same load and in the same thermal conditions. The air gap increase is smaller in the 0°-180° direction (this is direction X) than in the 90°-270° direction (this is direction Y).

It should also be noted that the trends of changes in the air gap data and TGB statical shaft positions correlate. There is a simultaneous increase in the air gaps and changes in the statical shaft positions on TGB, after which the vibrations on TGB stabilize along with the shaft statical position. At the same time, the increase in the air gap stops.

So, it can be clearly seen that there is a correlation between the increase in the shaft vibrations, shaft statical position in TGB and the average air gap value.

The continuous increase in the air gap, in steady-state thermal and operating conditions indicates there is a stress induced on the generator parts such as, for example, the stator frame to core interface or upper guide bearing bracket arm beams (which is braced against generator stator). This kind of increase is hardly possible without the irreversible deformation of some construction part(s).

The authors think that it is possible that the asymmetry of radial deformations on the upper bracket connection to stator frame, caused a shift of the upper guide radial bearing centre and its bracket on which the upper guide bearing is founded. These displacements can result in the entire rotor line displacement, due to which shaft's run-out in the turbine region is increased and, consequently, vibrations are increased.

In the conditions which were permanently present after September 30<sup>th</sup> the unit was continuously operating with very large vibrations for the next twenty (20) days, followed by sudden decrease in the vibrational amplitudes. As shown on Fig. 3 at the end of the process it seems that the vibration-wise the unit state has stabilized (if only shaft displacements were observed).

In the same time period, the statical shaft position at TGB returned to its original position before the vibrations started increasing.

It is also visible that change in shaft statical position was followed by decrease in shaft displacement (relative vibrations) on TGB.

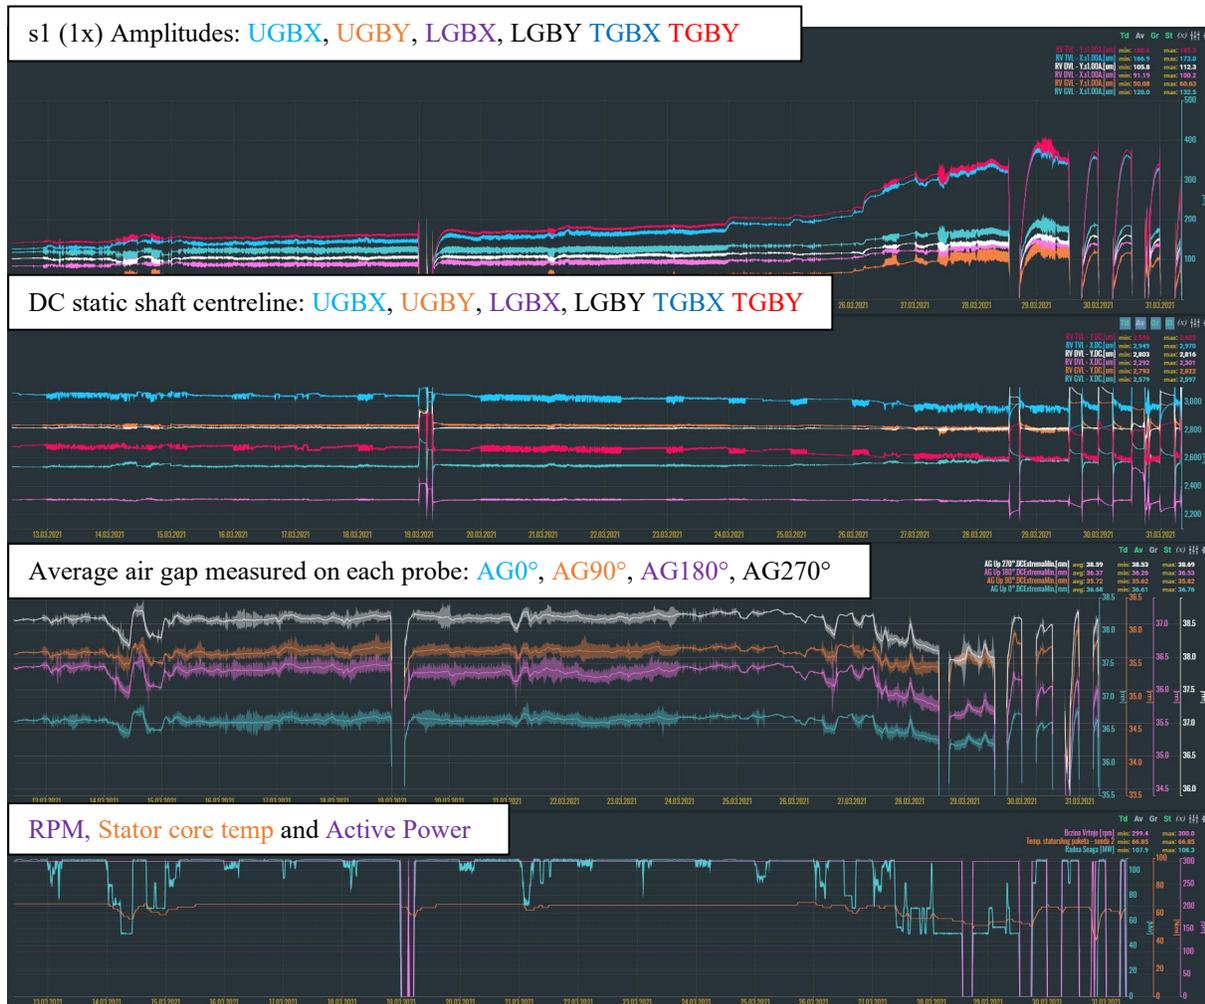
The second vibration destabilization manifested as a slow and continuous vibration amplitude increase. As in a previous destabilization, the fastest increase was on a turbine bearing. An abrupt vibration increase occurred after six (6) months when the vibrations on TGB increased for 100  $\mu\text{m}$  (from 220 to 320  $\mu\text{m}$ ) in one day. Fig 4. shows changes for the same vibrational descriptors (calculations) as those on Fig. 3 when new changes (vibration increase) were present.

At the end of the diagram, the amplitudes of the first harmonic of relative vibrations on TGB reached 300  $\mu\text{m}$  peak in X and 320  $\mu\text{m}$  in Y directions.

Average air gap values on four (4) sensors (second diagram on Fig. 4) have increased when compared to the beginning of the process (Fig. 4) and during the entire period from the first destabilization. It is noted that the stator core (and most probably the frame) thermal deformations are present manifested through continuous air gap increase.

Fig. 4 DIAGRAM 1 (TOP): 1x harmonic (relative vibrations peak); DIAGRAM 2: Static shaft position on UGB, LGB and TGB; DIAGRAM 3: Average (DC) value of all air gap values by pole; DIAGRAM 4 (BOTTOM): Stator core temperature, active power, rotational speed.
